EXERCISE DESERT ROCK LAS VEGAS NV

EXERCISE DESERT ROCK V. JANUARY-JUNE 1953. VOLUME I. OPERATIONS--ETC(U)

Exercise Desert Rock V

Volume I - Operations

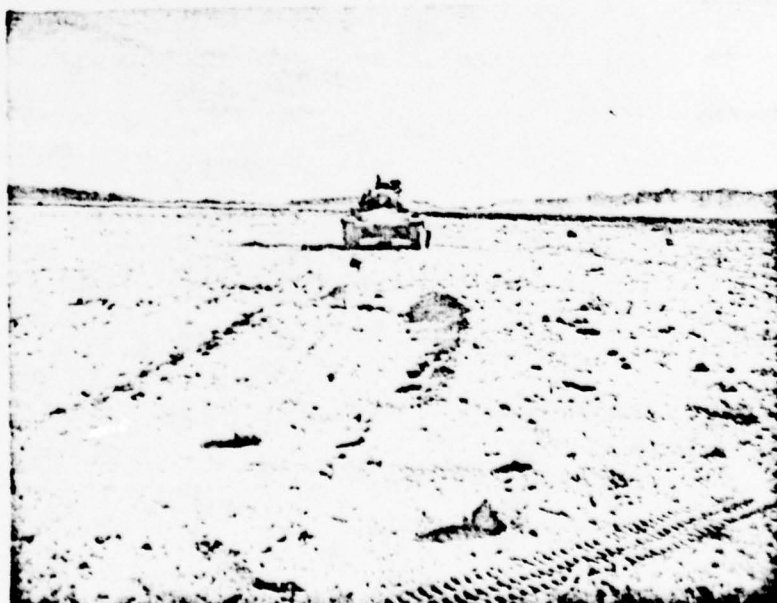
Vehicle pushed  
straight back 60 ft.  
Front of vehicle  
burned interior wir-  
ing ripped loose

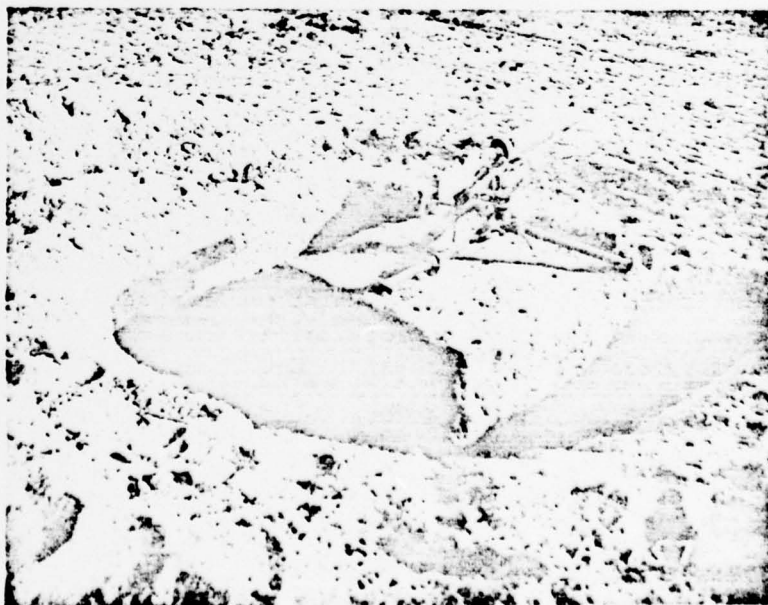
No visible damage

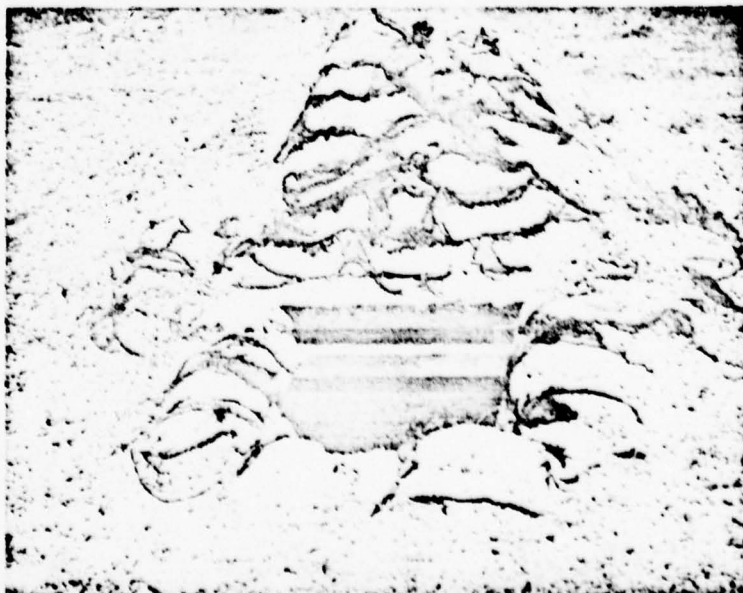
C-4 1,000 yds. All  
sand bags needed re-  
placing. Structure  
slightly damaged &  
full of sand.

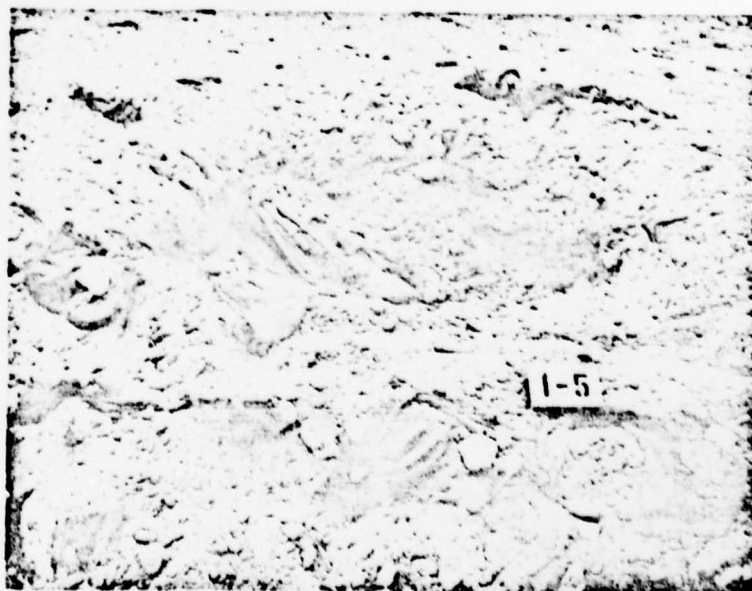
Tube detached from  
base plate and  
thrown half out of  
emplacement. Bipod  
damaged.

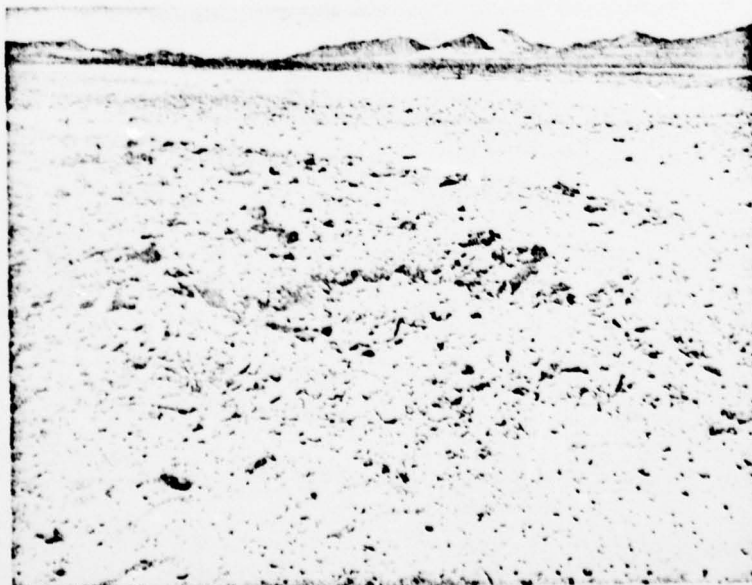
Blown out of emplace-  
ment. Barrel and jack-  
et bent. Damaged be-  
yond repair.

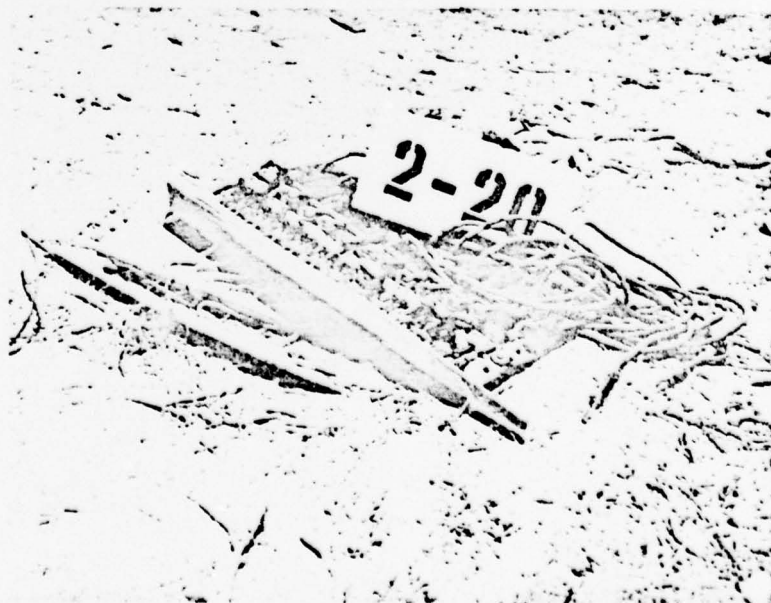
Thrown 30 feet and  
damaged beyond re-  
pair.

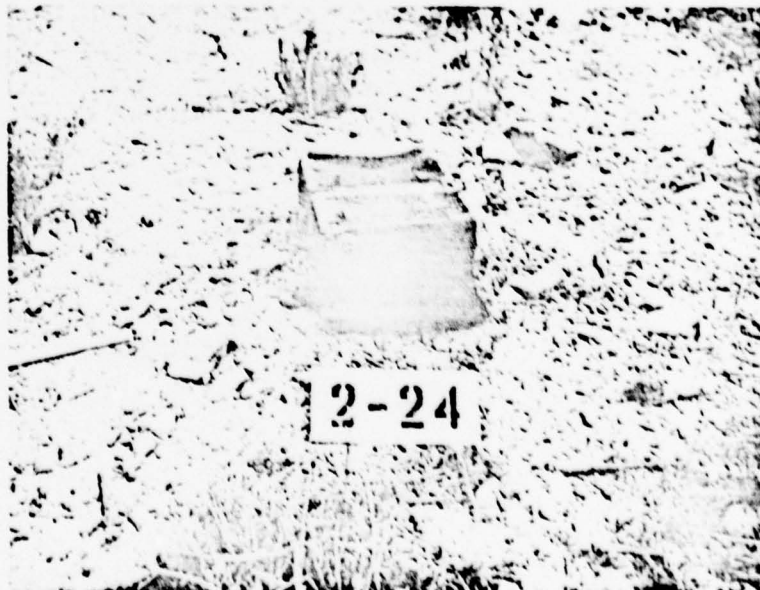
Thrown 90 feet. Se-  
verely damaged.

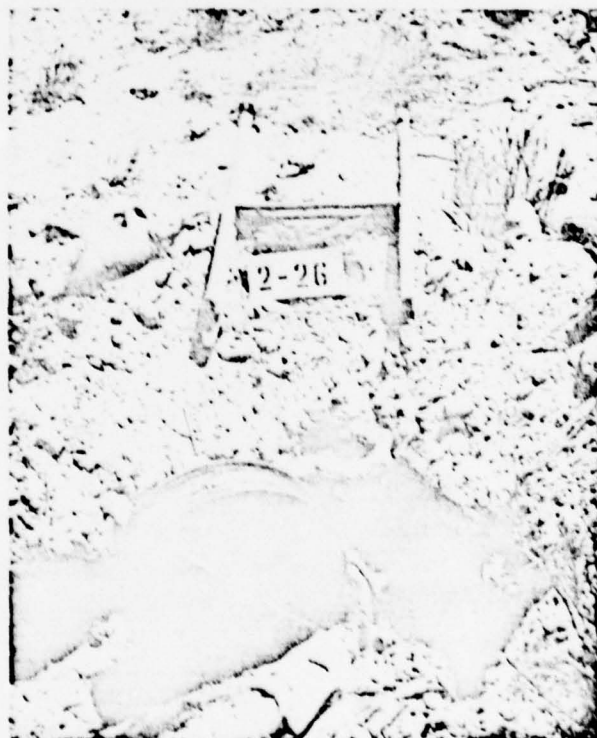
Drum broken from reel. Both  
thrown 40 feet. Wire insula-  
tion charred.

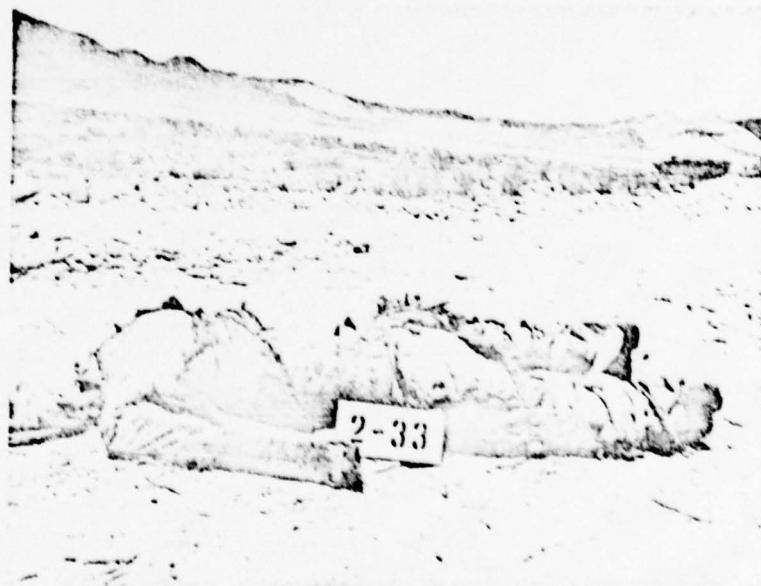
Dummy thrown approximately 150 feet, clothing burned, stocks of rifles badly scarred. Rifles apparently otherwise undamaged.

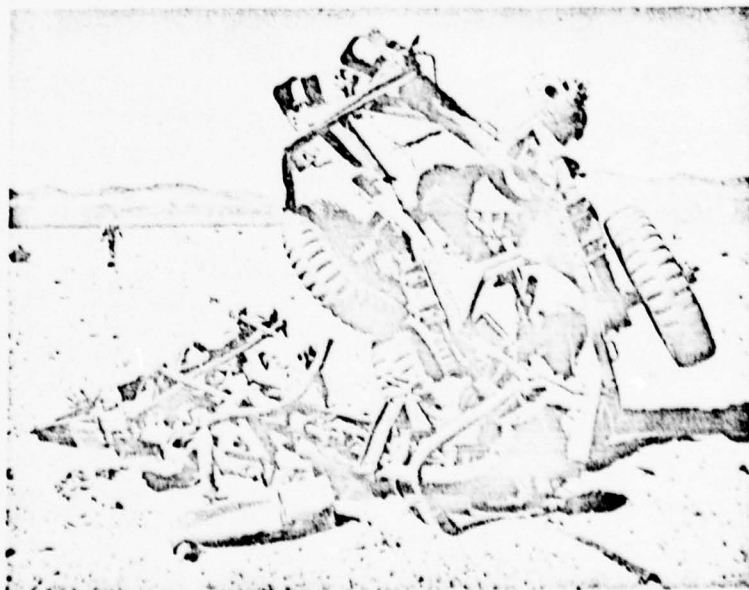
Completely destroyed.  
Engine laying 500  
yards from GZ. Other  
parts laying 700 yards  
from GZ. Frame and  
wheels found approx-  
imately 500 yards  
from GZ.

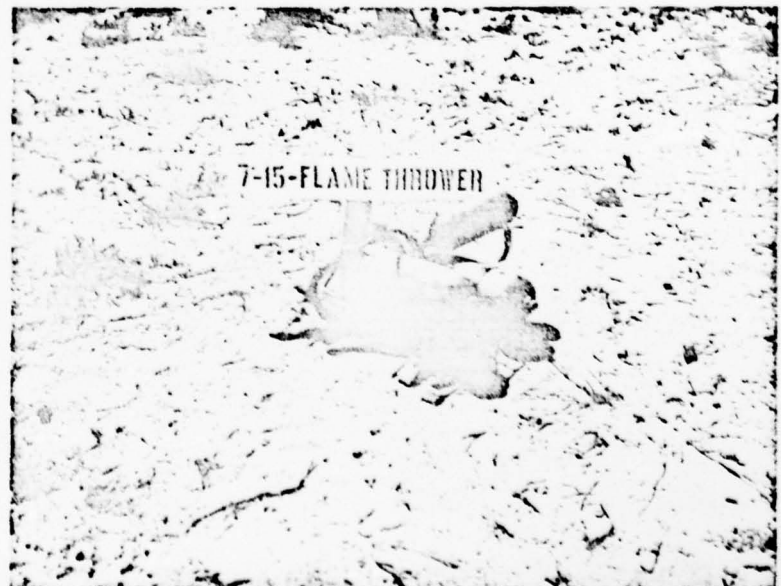
Band holding tanks  
together is broken.  
Hose and harness  
badly scorched.
